Manhole Inspection Summary

Manhole # S55C2_015MH

Insp Date: **5/21/08 1:23 PM**

Location Address: **3501 Asiatic Ave.**

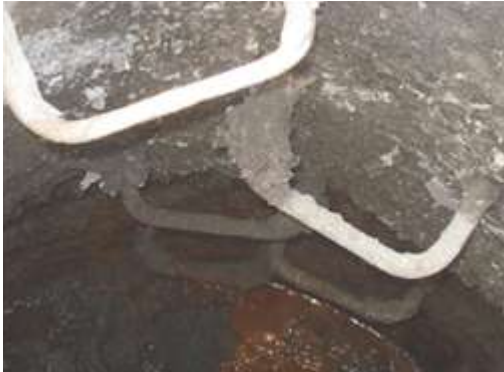
Steps

Count: **5** Missing: **0** ☒ **Corroded**

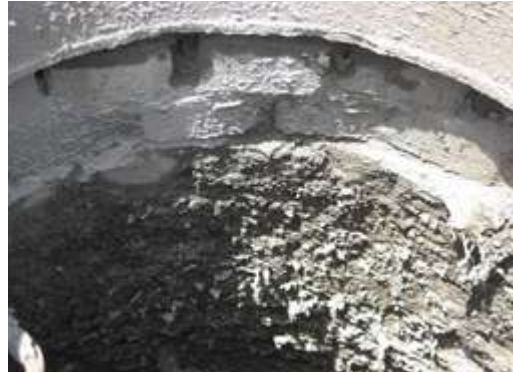
Defect 1

Infiltration through the joint

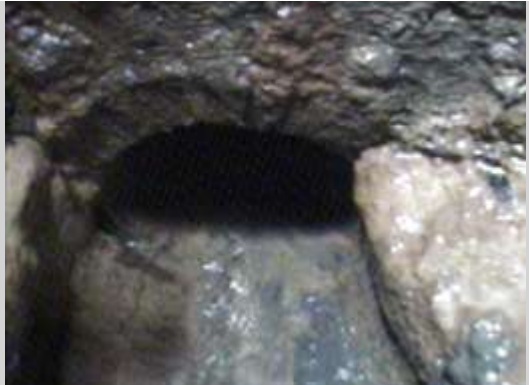
12 O'Clock Outflow

8 in. Circular Gravity Sewer
Pipe Out @ 12 O'Clock

Pipe Height: **8.4** (in.) Rod and Bar (Angled)
Pipe Material: **Clay** ☐ Pipe Lined
Invert Depth: **10.32** (ft.) Flow Characteristics: **Fast**
Deposits: ☒ None ☐ Mud ☐ Sludge ☐ Debris ☐ Grease
Silt Depth: (in.) Deposits Extent:
Infiltration: **None** Pipe Seal Cond: **Sound**

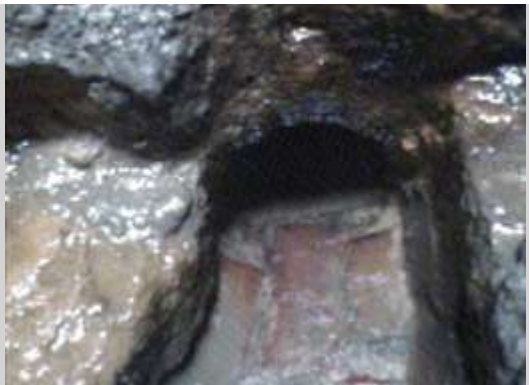
3 O'Clock Inflow

8 in. Circular Gravity Sewer
Pipe In @ 3 O'Clock

Pipe Height: **6** (in.) Rod and Bar (Angled)
Pipe Material: **Clay** ☐ Pipe Lined
Invert Depth: **10.22** (ft.) Flow Characteristics: **Fast**
Deposits: ☒ None ☐ Mud ☐ Sludge ☐ Debris ☐ Grease
Silt Depth: (in.) Deposits Extent:
Infiltration: **None** Pipe Seal Cond: **Sound**

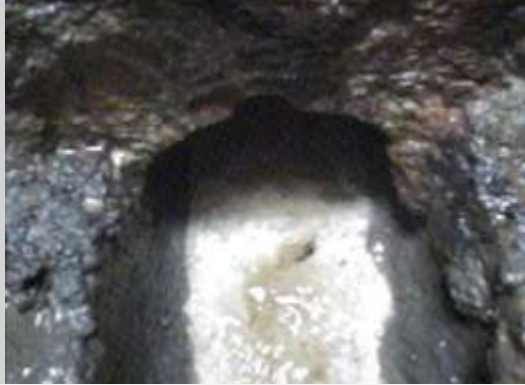
6 O'Clock Inflow

Infiltration: **None** Pipe Seal Cond: **Unknown**
